Manhole Inspection Summary

Manhole # S3500_016MH

Insp Date: **1/24/07 10:38 AM**

Location Address: **339 CAMP ST**

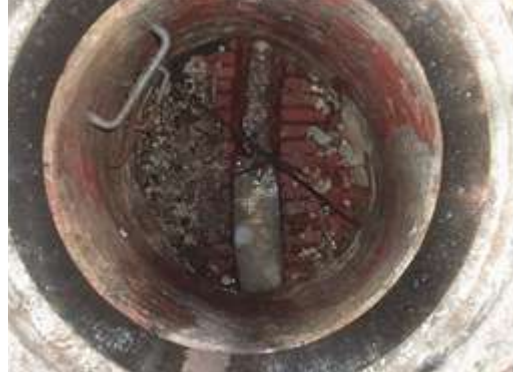
Top View

Adjustment and Barrel infiltration.
Corroded steps. Bench and Channel
debris.

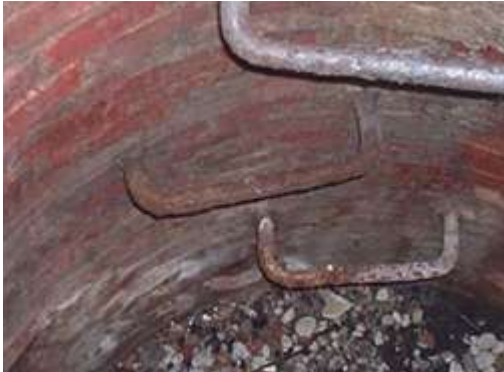
Defect

Barrel infiltration.

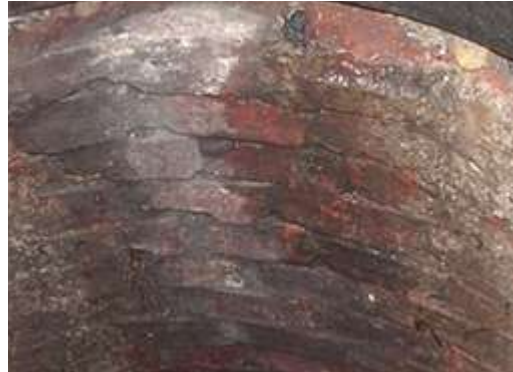
Defect

Frame leaks. Adjustment deterioration
and infiltration.

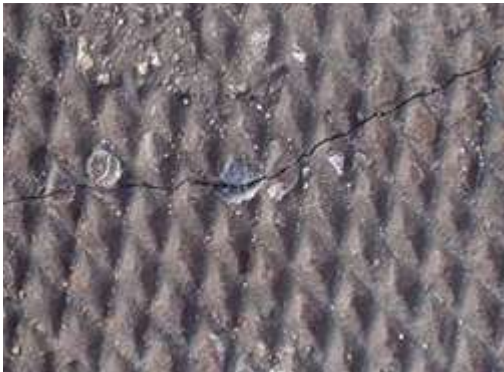
Defect

Cracked lid.

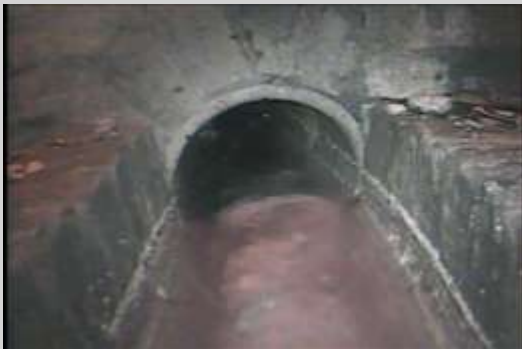
8 in. Circular Gravity Sewer Pipe In @ 6 O'Clock

Deposits: ☐ None ☒ **Mud** ☐ Sludge ☒ **Debris** ☒ **Grease**

Silt Depth: **0.5** (in.) Deposits Extent: **Light**
